**Results of the 2007
Valley of Peace Archaeology Project:
Yalbac's Settlement**

Report submitted to the Institute of Archaeology
National Institute of Culture and History
Government of Belize

Edited by
Lisa J. Lucero
University of Illinois at Urbana-Champaign

2008

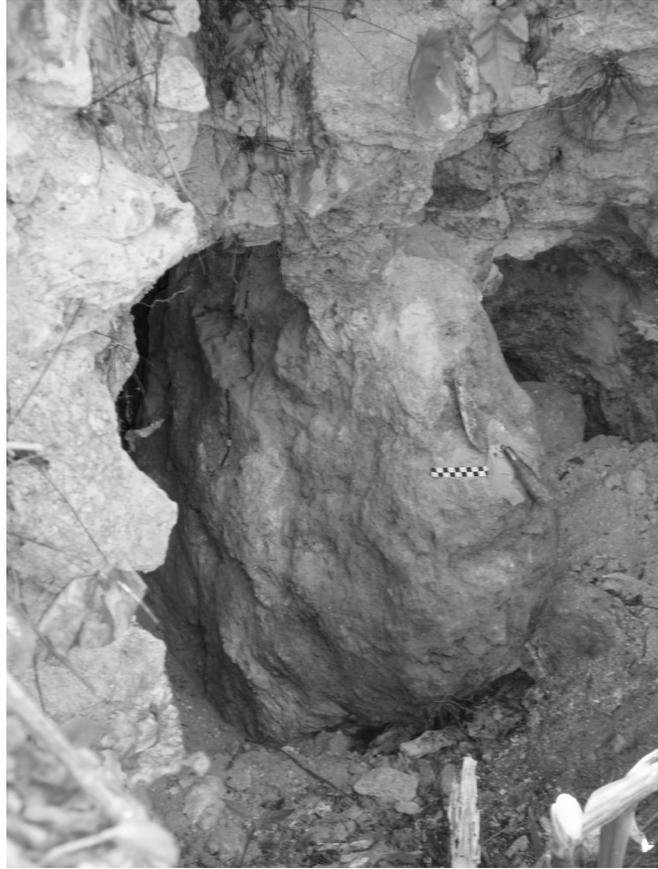
While we did not find a stela, we did find a plain altar stone in the fill of Str. 4, the 'toll house.' Cleofo Choc was cleaning out LT 23 and noted its presence. He probed the surrounding fill for diagnostic ceramics, but did not recover any; he also exposed as much of the stone as possible to reveal its shape and any possible carvings. It is c. 30-35 cm wide and has a diameter of c. 1.25 m (Figure 1.3). The Maya placed the altar stone on its side in the middle of the structure oriented c. 60°.

Figure 1.3 Altar stone in LT 23, Structure 4.

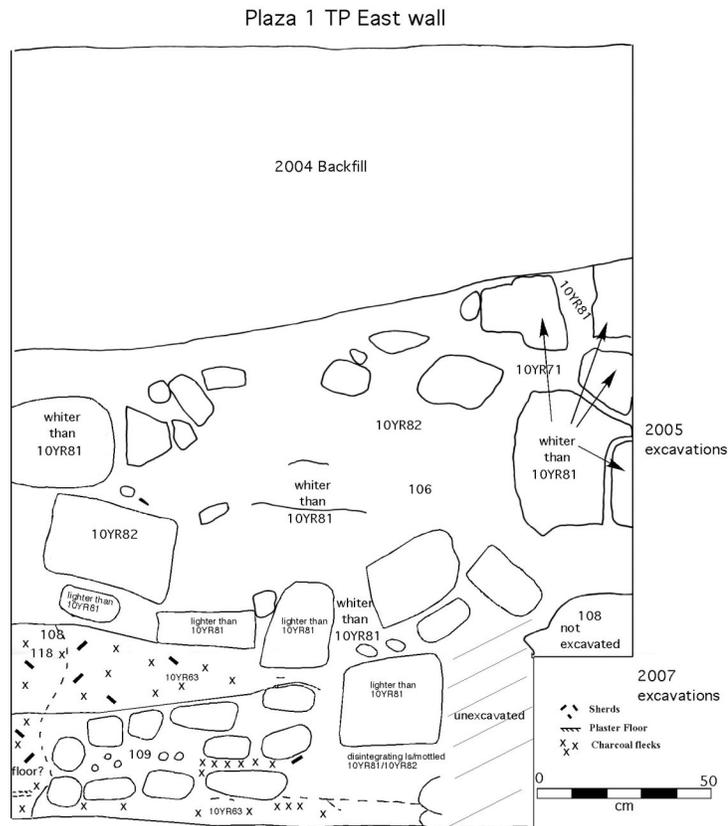
Figure 1.7 Plaza 1 TP east wall

Due to the similarity of these strata, we inadvertently dug through a few strata a little, which we realized in the west wall profile. Stratum 110 (cobble and sandy clay fill), which we dug through while excavating 107; it was noted in the northwest corner of the unit. Once we realized this, we began excavating 107 and 110 separately, though not much was recovered from 110. Also missed were plaster floor 111, fill 112 (underneath 111), and fill 113 (loose cobble and sand fill). Fill 113 is found beneath 107 and did not yield any obvious artifacts. At first, it appeared that stratum 112 cut through floor 114 (over 115); however, once we removed floor 114, strata 112 and 115 appear to represent the same event/deposit. Artifacts from 112 largely concentrated in the north side. In the northeast corner underneath 112 we exposed stratum 117, a white marl or plaster fill with medium boulders, which we did not excavate. Stratum 116 may have been a wall.

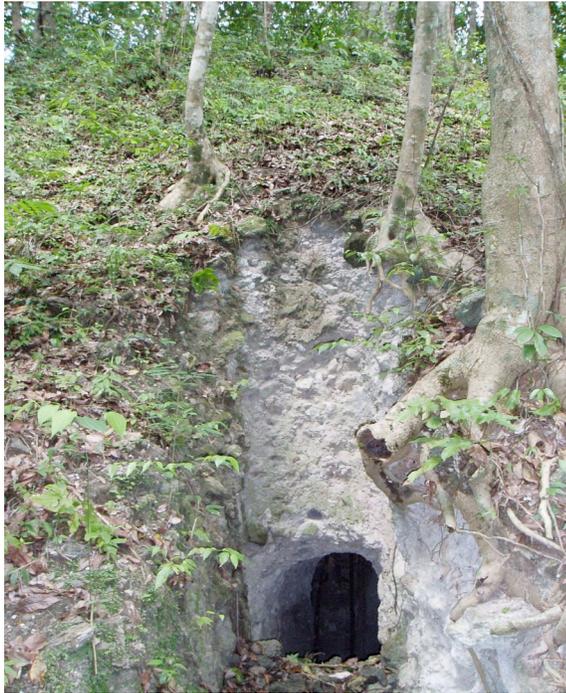
Figure 2.1 Tunnel trench

Trench exposure type was also noted and classified into three types: tunnel trench, exposed trench, and a trench with an overhang (natural or architectural). Tunnel trenches were usually some of the largest trenches found at Yalbac, and also preserved the architecture the best (Figure 2.1). An exposed trench completely exposes architecture (Figure 2.2). Trenches with natural (e.g., roots) or architectural overhangs were usually trenches that had some degree of protection from the elements (Figures 2.3 and 2.4). The effects of exposure were also taken into account; for example, if mold caused by rain was visible on the walls, if sunlight hit the exposed architecture, or the apparent lack of climatic effects (e.g., tunnel trench). Root activity was also noted since Yalbac is completely covered in vegetation; the roots of trees typically protruded through the architecture. If roots were horizontal, it indicates that the mortar was compact and/or that larger stones were used; if roots were vertical, it indicates a looser mortar or fill.

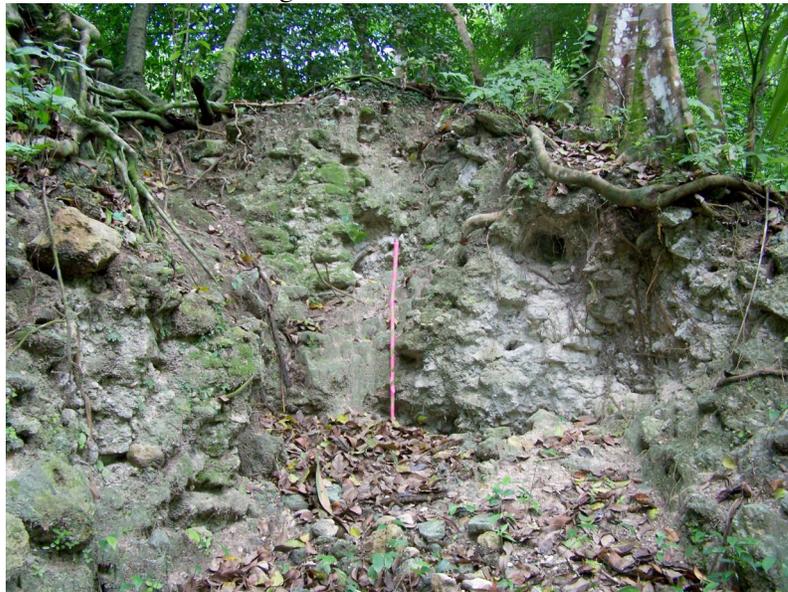
Figure 2.2 Exposed trench

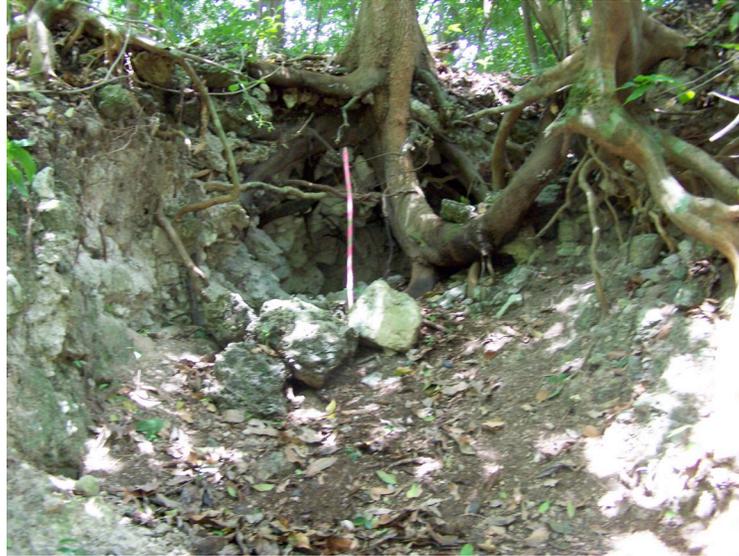
Figure 2.3 Natural overhang

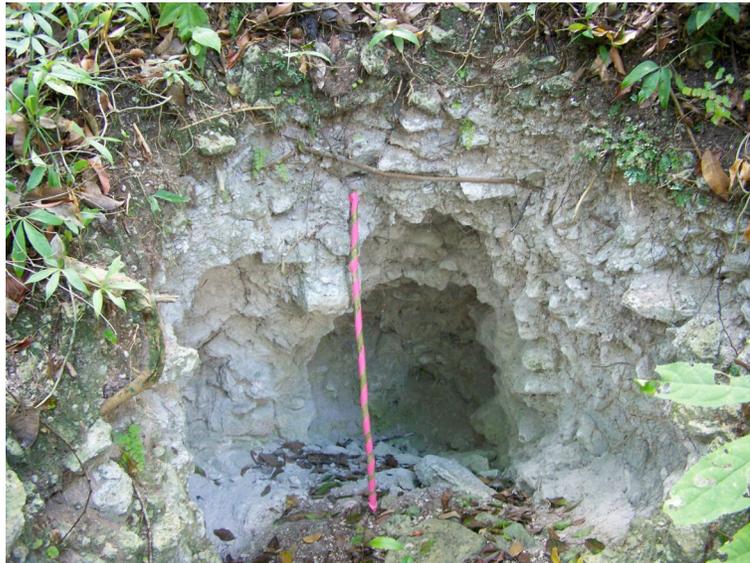
Figure 2.4 Architectural overhang

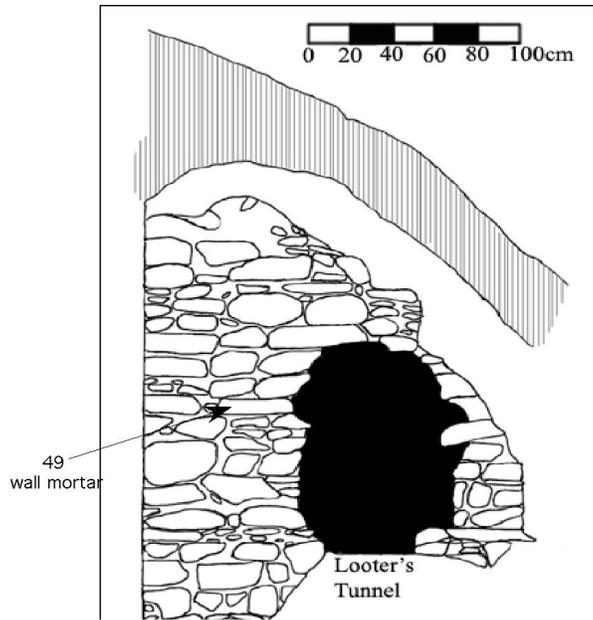
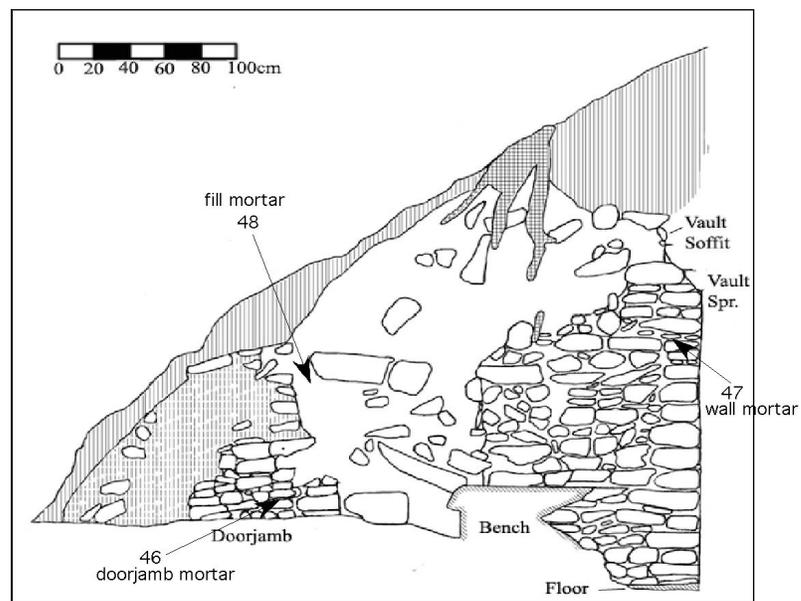
LT 2 (Str. 1A-1a-I) is a tunnel trench with an exposed bench (which had been covered prior to 2007 with plastic and soil to protect it), two exposed walls, and a doorjamb at the entrance. The walls were made with soft stone (hard stone is only seen in the LT debris) and are protected by the architectural and root overhang. Some vertical root activity is seen at the top of the trench. A total of five samples were collected from locations including the doorjamb, two walls and the bench exposed in the sidewall, with colors ranging from 10YR 6/2 to 10YR 8/1 (Figure 2.7). Samples were loose with pebbles, minor root fragments, and noticeably affected by insect disturbance. The sample taken from the bench was very white (10YR 8/1) and compact. Two burnt stones were noted in the south wall.

Figure 2.7 LT 2, Str. 1A-1a-I. Sample #50 was taken from the north wall, not shown here. The top profile is the west wall; the bottom one the south wall.

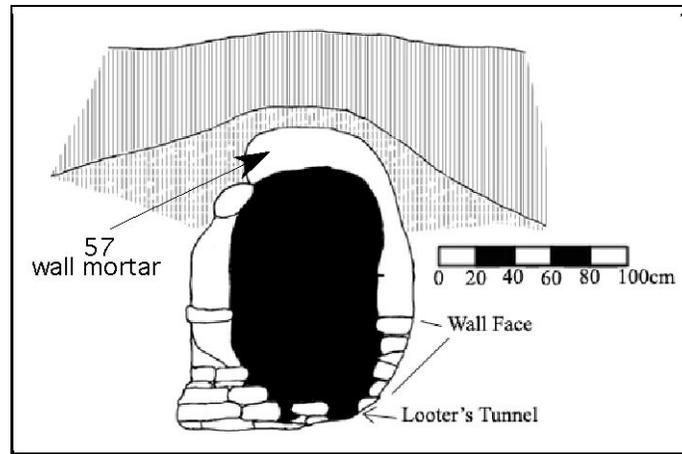
LT 3 (Str. 1A-1a-I) is a semi-tunnel trench with an exposed vaulted ceiling with soft weathered stone and noticeable insect disturbance. Only one sample was retrieved, which was very loose and greatly affected by bee nesting (Figure 2.8).

Figure 2.8 LT 3, Str. 1A-1a-I. West face.

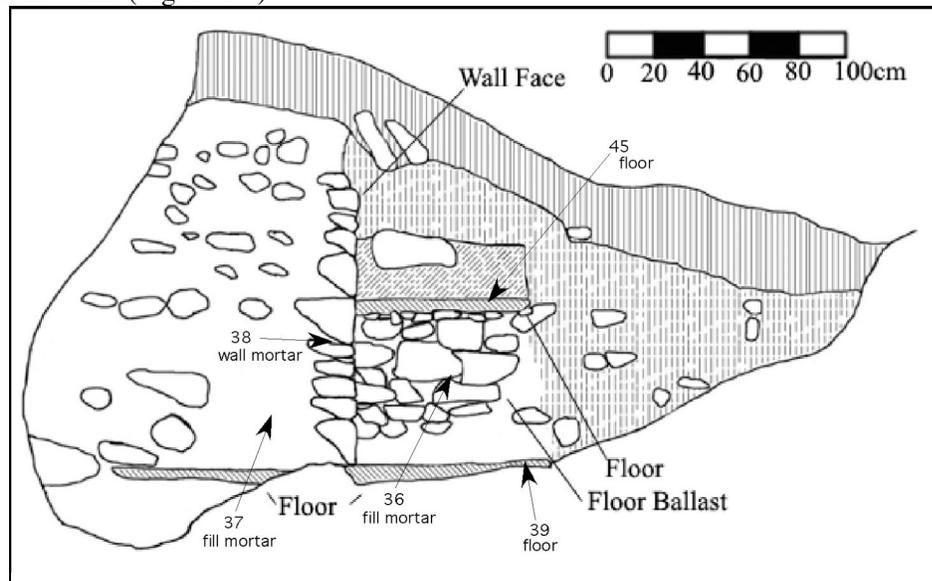
LT 12 (Str. 1A-2b) is a narrow tunnel trench that exposed several plastered steps and two walls. A thin capstone found on the floor indicates that the trench once had a vaulted ceiling. There is little root activity and exposure to the elements is limited due to the narrowness of the trench; however, some mold still appears on the north wall. A noticeable amount of insect disturbance was noted. Five samples were collected: two very white and tightly packed from the floor (10YR 8/2); and three quite loose with small pebbles from the walls (Figure 2.9).

Figure 2.9 LT 12 Str. 1A-2b. South wall.

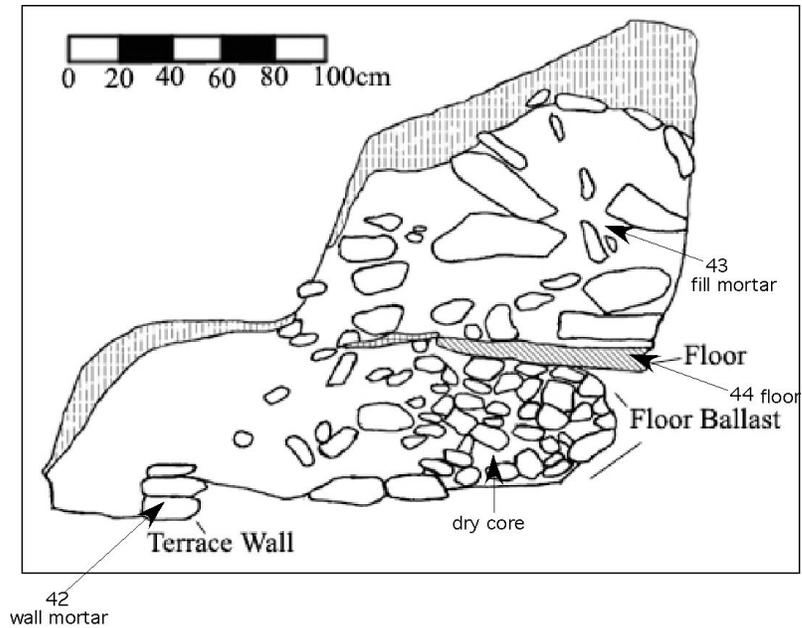
LT 13 (Str. 1A-1b-II) is an exposed trench that has been backfilled for preservation purposes. The exposed architecture appears to be mortared soft stone (hard stone is only seen in backfill and LT debris), that has been greatly affected by the elements (mold); root activity is visible in the west wall. A high concentration of mud bees impacted the trench. Three samples were taken (Figure 2.10): two from the walls were very loose, perhaps due to the bees; the floor sample was very white and compact.

Figure 2.10 LT 13, Str. 1A-1b-II. East wall.

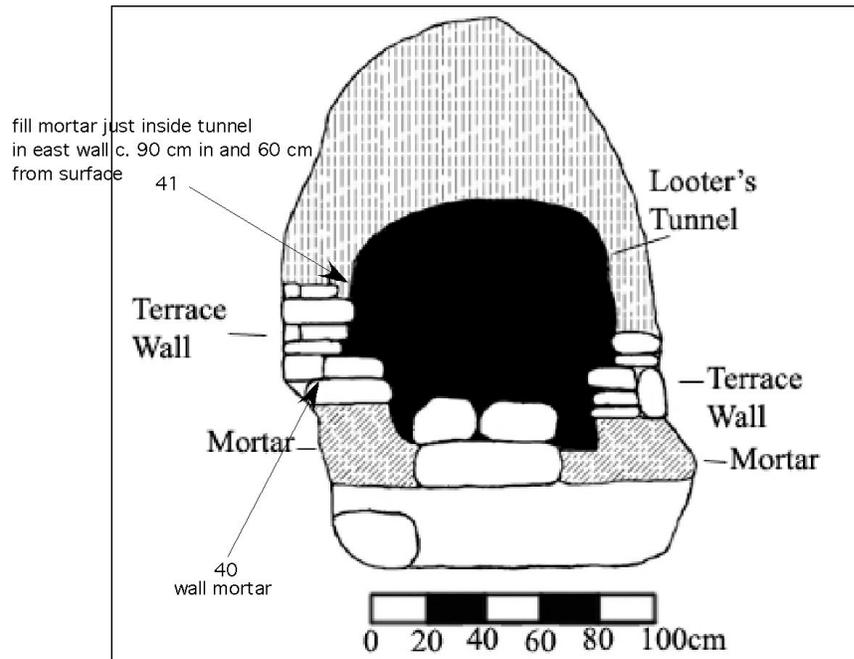
LT 14 (Str. 1A-1b-II) is a tunnel trench, the entrance of which has a wall with faced stones neatly laid with mortar. Some root activity is seen at the top of the trench, as well as some insect disturbance. The effects of the weather (mold) are visible at the entrance of the tunnel. Samples were difficult to collect since the mortar was so compact. Two samples were retrieved: one from the entrance, which was loose with a Munsell color of 10YR 7/2; and one from the inside of the trench on the east side 90 cm in and 60 cm up from the surface (white, 10YR 8/1, and compact) (Figure 2.11).

Figure 2.11 LT 14, Str. 1A-1b-II. North face.

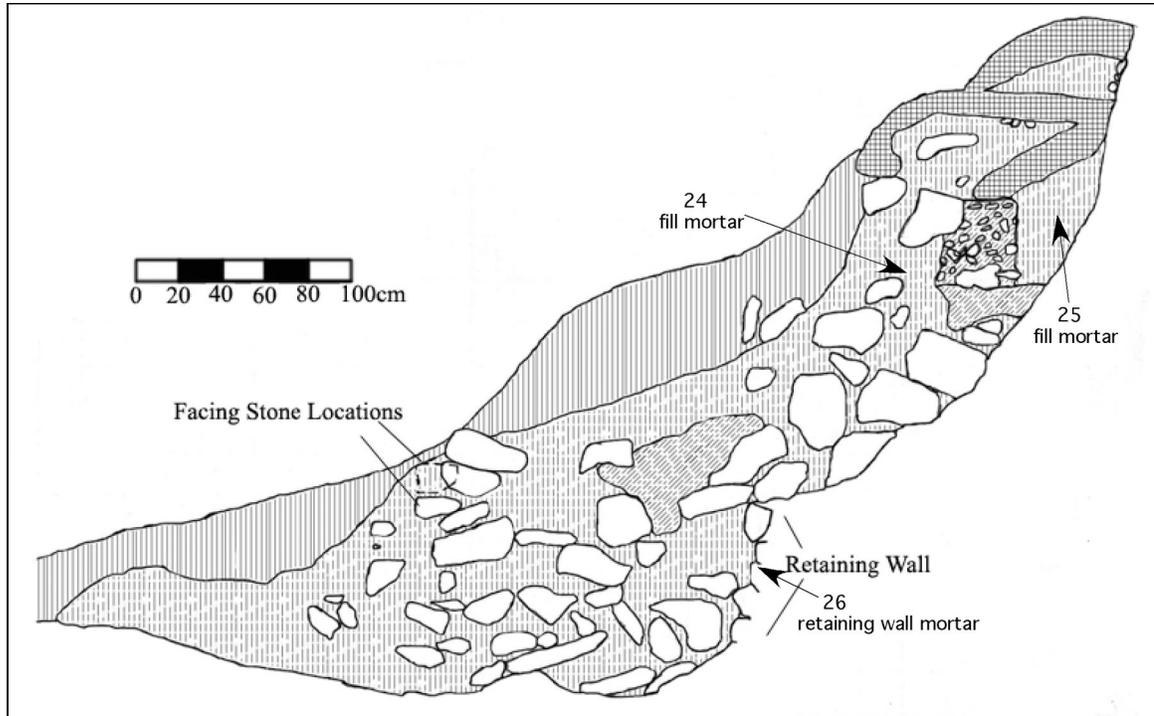
LT 17 (Str. 1A) is a narrow exposed trench with a partial root overhang located at the base of the acropolis on its east side. Part of the trench had been backfilled for preservation purposes. The trench exposed a retaining wall made of large uncut boulders, above which was fill consisting of pebbles and cobbles (pink and yellow) with mortar. Small plaster-encrusted sherds were found within the mortar (annular base, 3 jar necks, Late Classic turnip jar sherd, Late Classic red-slipped volcanic ash bowl rim). There was a noticeable amount of stone types, with large hard stones predominating. Three samples were collected (Figure 2.12). Two of the samples, taken from the cobble and pebble layer, were loose and had a much greyer color (10YR 6/1) than any other mortar taken in Plaza 1. The third sample, taken from the retaining wall, was much like the previous two.

Figure 2.12 LT 17, Str. 1A. South wall.

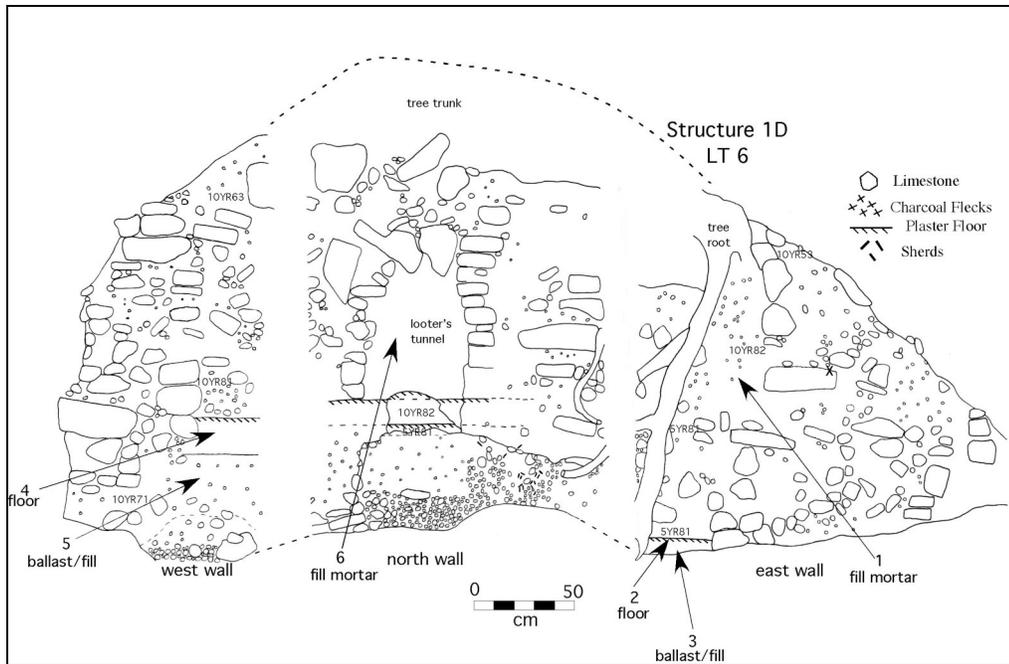
LT 6 is a tunnel trench with a massive root overhang. It consists of "stone blocks, thick, hard and smooth plaster floors, sandy plaster mortar, and substantial standing walls" (Lucero 2006:5). The opening and inside of the tunnel are plastered and very white, and appear to be constructed with predominantly soft stone. Six samples were collected from the walls and floors (Figure 2.13). Samples were relatively loose with small pebbles with colors ranging from 7.5YR 6/2 to 10YR 8/2.

Figure 2.13 LT 6, Str. 1D. West, north, and east walls.

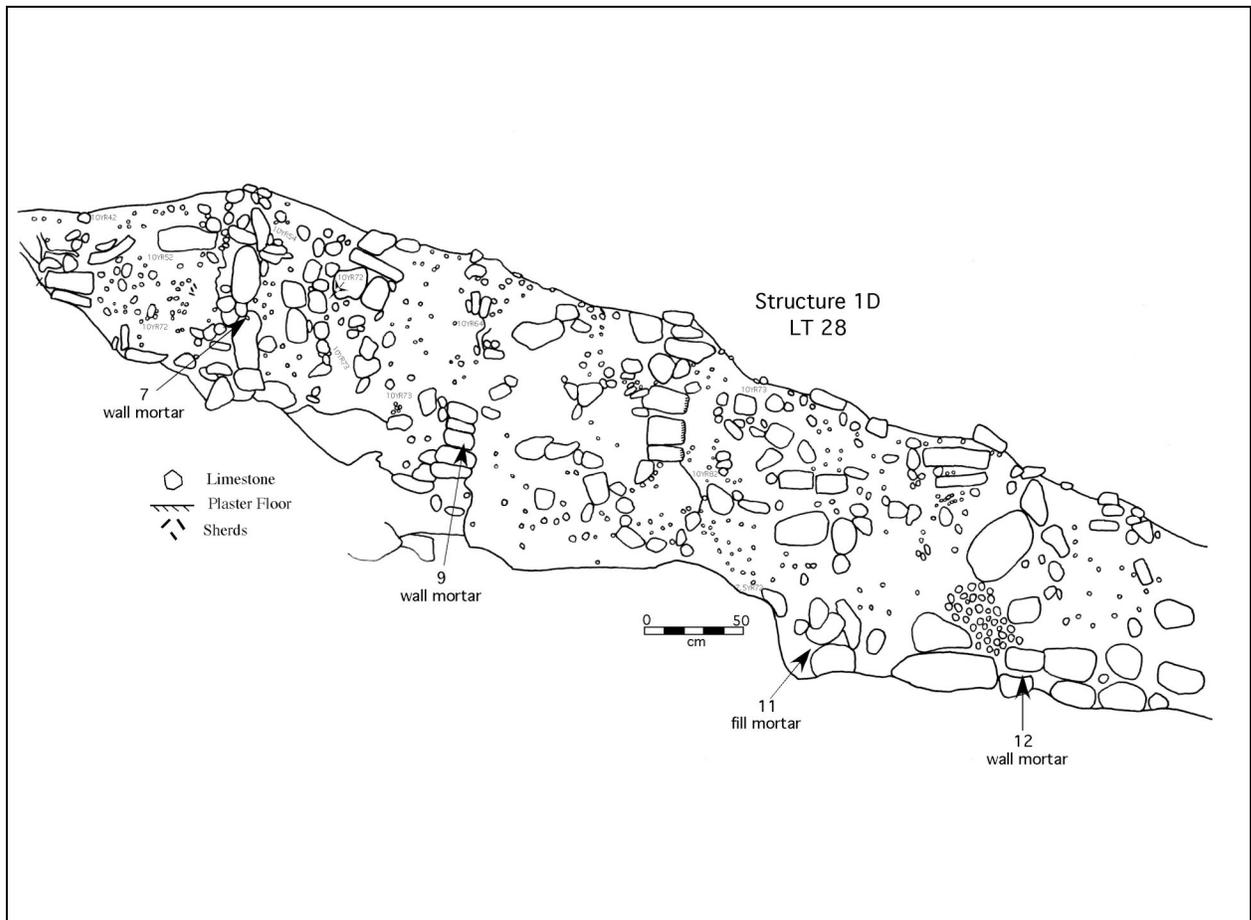
LT 28 is an open trench located on the back or northeast corner of Structure 1D and "reveals four terraces with relatively loose sandy plaster mortar and a cut stone façade, some of which is plastered" (Lucero 2006:6). Shaped and unshaped boulders were noted in the trench. LT 28 is extremely affected by sun and rain (mold) since it is completely exposed; thus, it is not surprising that its mortar is looser than that found in LT 6. Some root (60% of which are horizontal) and insect disturbance were also noted. A total of six samples were taken from this trench, all notably looser than samples from LT 6 (possibly due to the exposure of the trench), but with an overall similar color (10YR 7/2, 10YR 8/2) (Figure 2.14).

Figure 2.14 LT 28, Str. 1D. West wall.

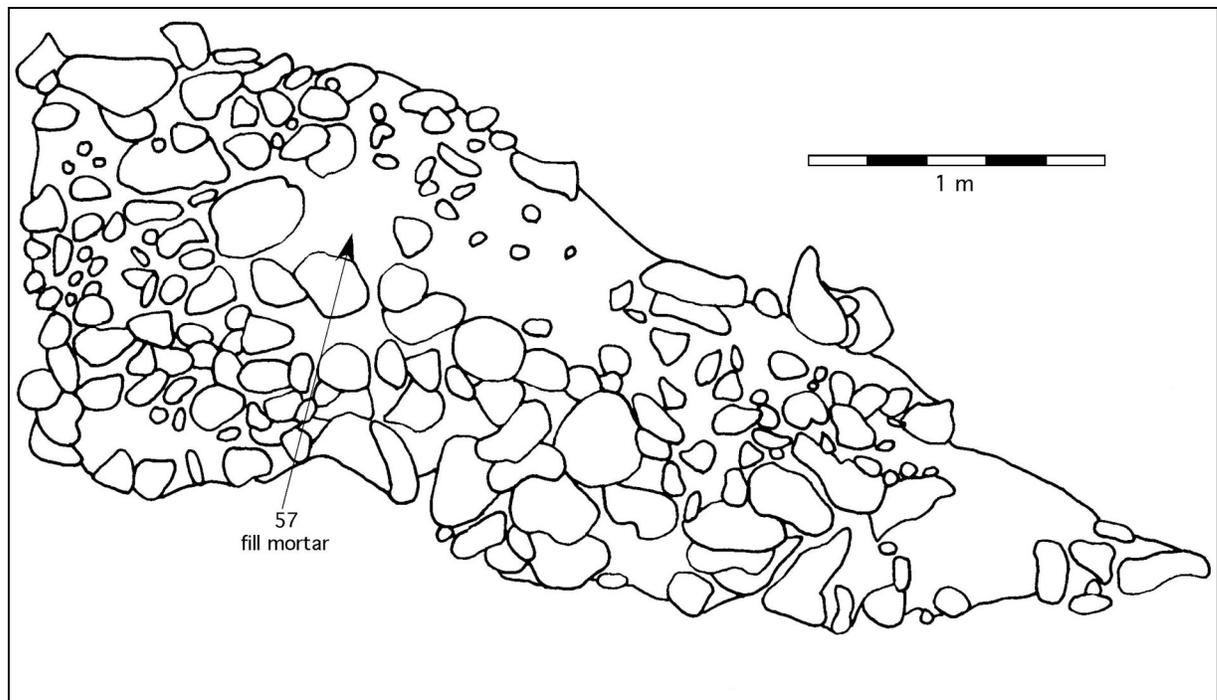
Structure 2C is the eastern structure of the only ball court at Yalbac and the only one with LTs (LTs 18, 19, and 20); its counterpart is Structure 2B, which is attached to Str. 2A. We focused our efforts on LT 18 because it exposed the most architecture. This structure appears to be made predominantly with a dry core of large stones and pebbles and hardly any mortar (Baron 2005). LT 18 is located on the southeast corner of Structure 2C; it is a narrow trench with some architectural overhang. The trench is noticeably affected by weathering (mold) and insect disturbance. Only one sample was retrieved from LT18 since it was difficult to locate any mortar, if it there is any (Figure 2.15). The sample was very loose and grey (7.5YR 6/2) with small pebbles, perhaps a mixture of loam and crumbling limestone.

Figure 2.15 LT 18, Str. 2C. North wall.

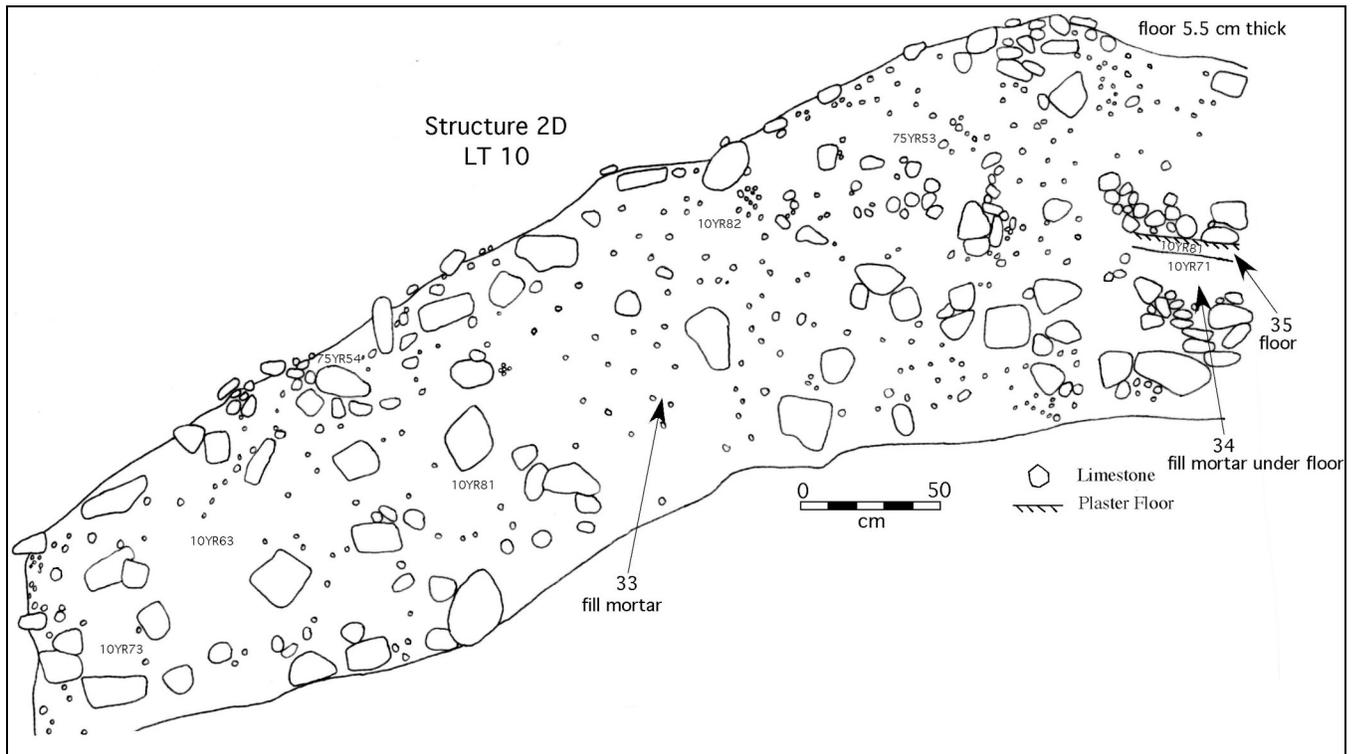
Structure 2D is a range structure located on the north side of Plaza 2. It has only one looter's trench (LT 10), on its southeast corner. LT 10 is a narrow trench with a natural (root) overhang; it has been noticeably affected by rain since mold is present. The trench exposed plastered walls and parts of a floor 5.5 cm thick in the north wall. The west wall appears to have been constructed with cobbles and plaster, while the north wall is made of larger soft stone. Three samples were collected from LT 10, one from the wall fill and one from the fill/ballast from under the floor (Figure 2.16). The fill samples were loose with pebbles and possible loam (10YR 6/2), and the floor sample was very white (5YR 8/1) and compact.

Figure 2.16 LT 10, Str. 2D. West wall.

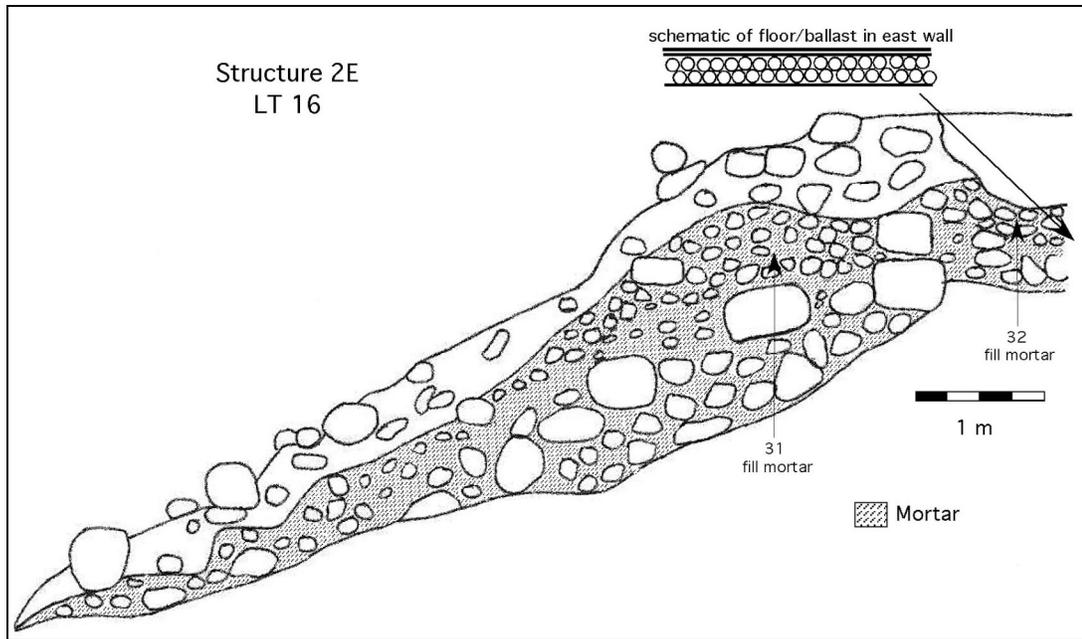
Temple 2E is located on the east side of Plaza 2 (Lucero 2005). LT 16 is located on the top west side facing the plaza. The trench has a large root overhang; the protected architecture is very white, while the rest of the trench is covered in mold. A few arranged stones indicate a possible floor made of mostly yellowish and white soft limestone (10YR 7/1, 10YR 8/2). The north wall is made of cut stone facades, shaped on all four sides. Two samples were collected from LT 16, which were consistent in color with plaza 1 samples, fine grained and no pebbles (Figure 2.17). An orange sherd was noted in the fill. From the debris we recovered a red-brick rock that appears to be basalt (very hard and porous).

We were curious if looters had expanded LT 16 since it had been profiled in 2002 towards the summit (east) (see Lucero 2003, 2005); either that or there has been additional collapse on the east wall under the overhang towards the center of the temple summit. We noted a possible plaster floor and ballast.

Figure 2.17 LT 16, Str. 2E. North wall.

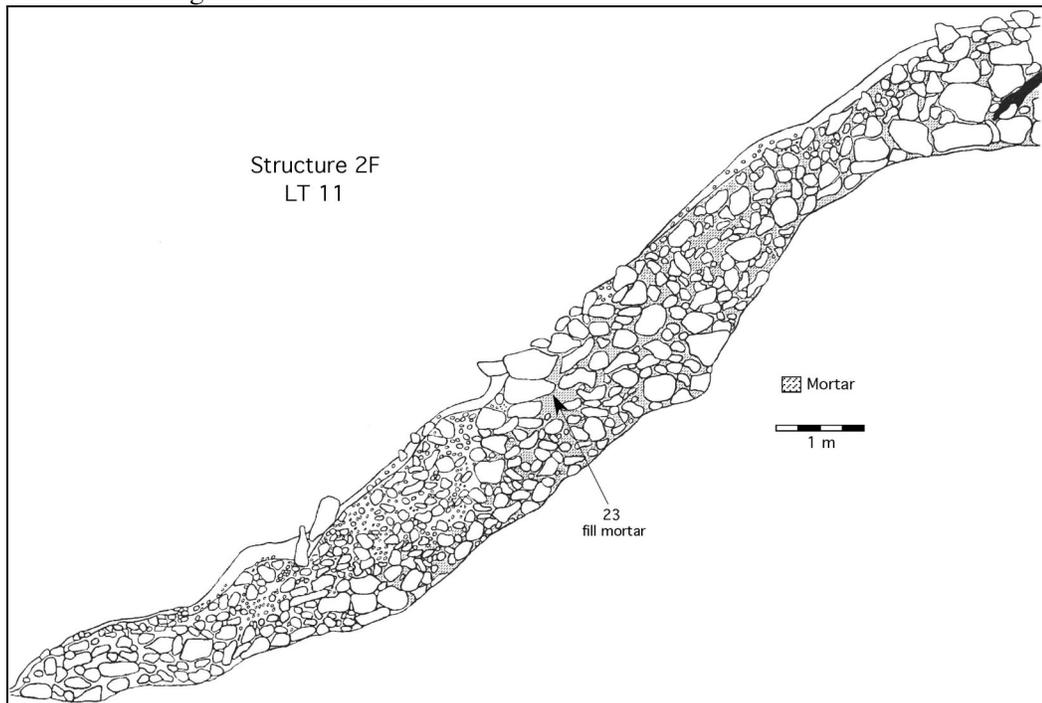
Temple 2F is on the southeast corner of Plaza 2 and has two LTs (11 and 21) (Lucero 2005). LT 11 is a narrow trench with an architectural and natural overhang and is located on the south side of the temple. The trench exposed a wall on the west side with faced boulders of green, yellow and orange limestone, and appears to represent one construction event. Mud bees impacted the trench. The one sample collected from LT 11 was loose and brittle with small pebbles (Figure 2.18). Upon closer inspection, it appears that what had previously been labeled clay loam mortar (Lucero 2003) instead likely is a mixture of crumbling limestone and soil.

Figure 2.18 LT 11, Str. 2F. West wall.

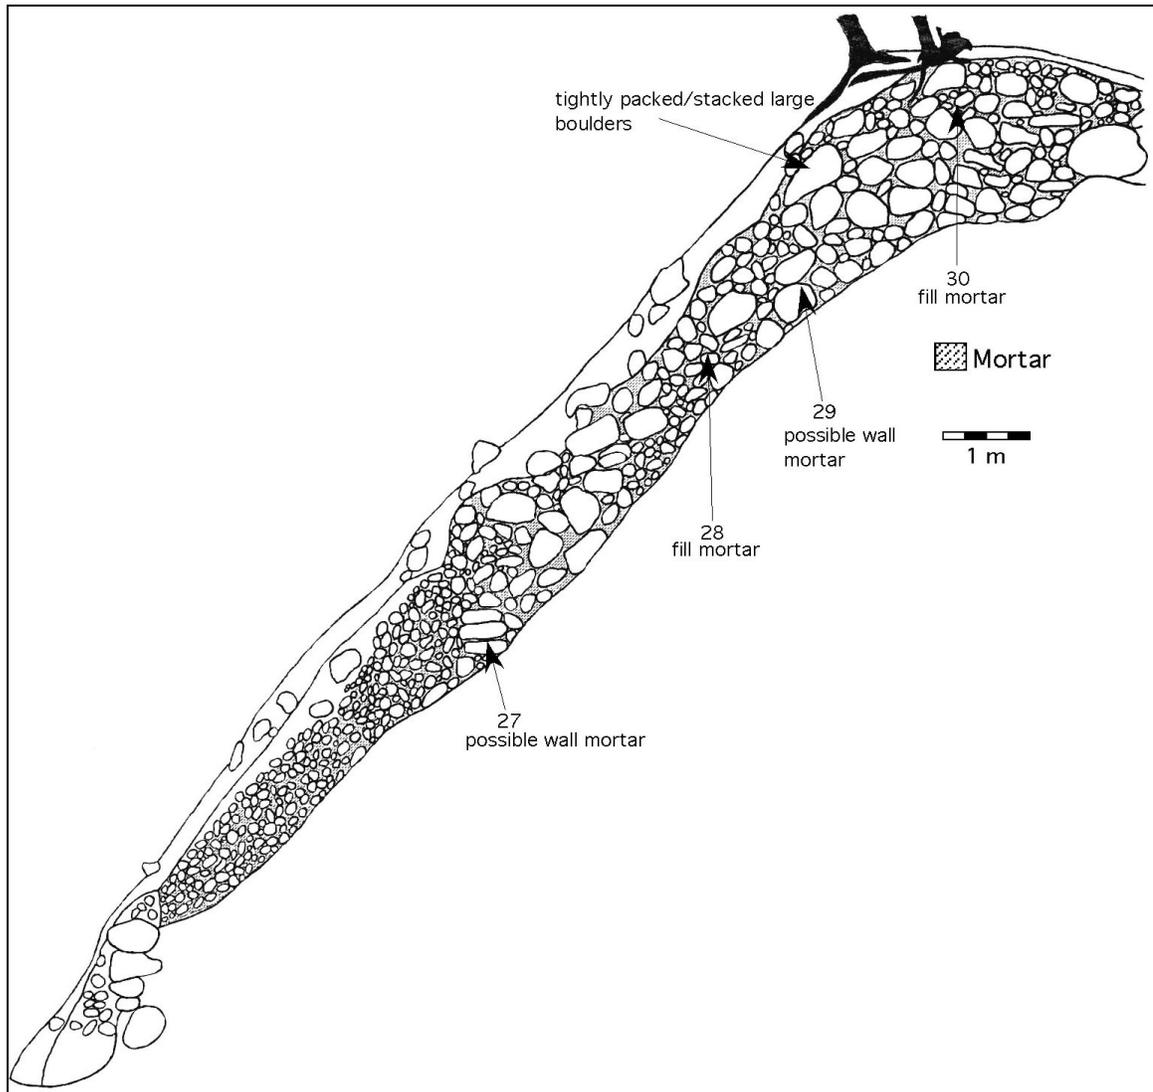
LT 21 is a massive exposed trench located on the west side of the temple facing Plaza 2. The trench is noticeably affected by water and insect disturbance; minor root activity was also noted. At least three distinct terrace walls are exposed on the north wall of the trench consisting of boulders and faced stones. The four samples retrieved from LT 21 were consistently loose with pebbles and colors ranging from 10YR 6/2 to 10YR 7/2 (Figure 2.19). The outer wall of the upper most terrace consists of a tightly stacked row of large faced boulders—perhaps even without mortar.

Figure 2.19 LT 21, Str. 2F. North wall.

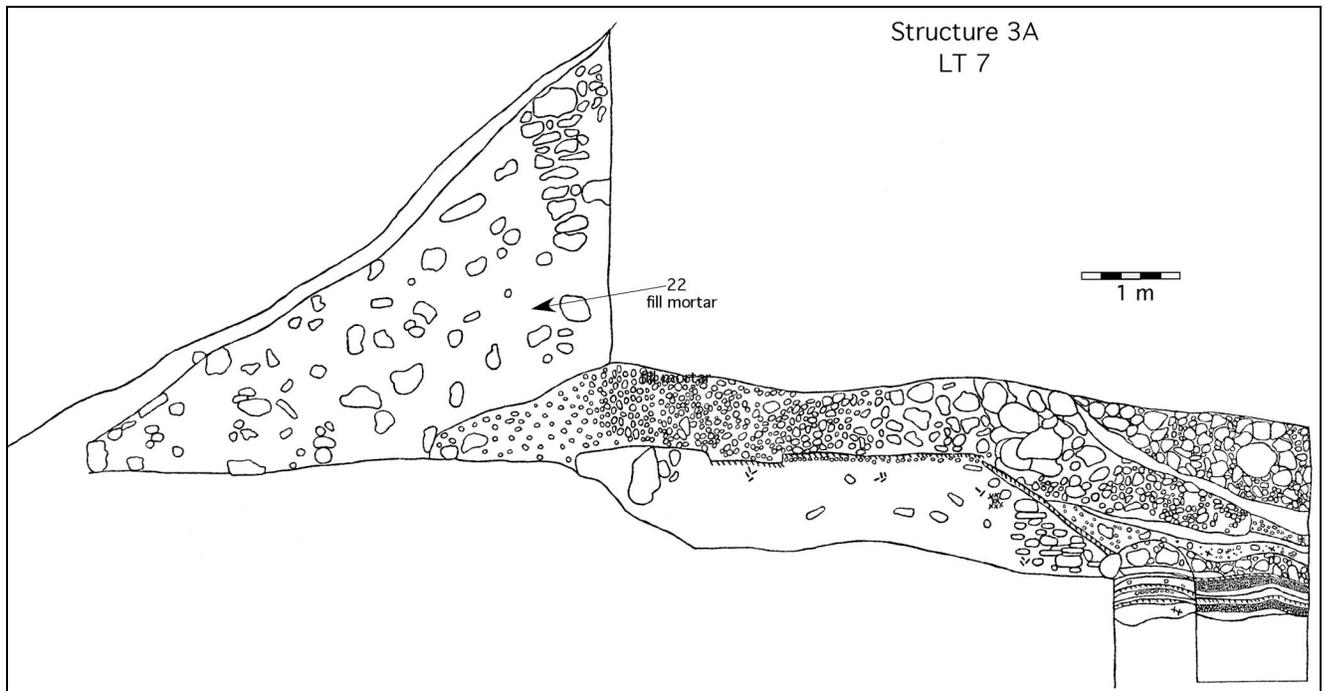
LT 7 is a tunnel trench located on the back or west side of Temple 3A. Its entrance is completely mortared; dry core is seen on the inside of the tunnel in earlier construction phases. Even though the walls have been protected, mud bees have invaded the trench and left their mark. Their effects were evident in the one sample taken from the north wall from the Late Classic construction phase (see Andrade 2005:Figure 3.5, area 18); mortar was grey (5YR 7/2) and loose with small pebbles (Figure 2.20). We did note the presence of pinkish, yellowish, and white limestone rocks in the fill.

Figure 2.20 LT 7, Str. 3A. North wall.

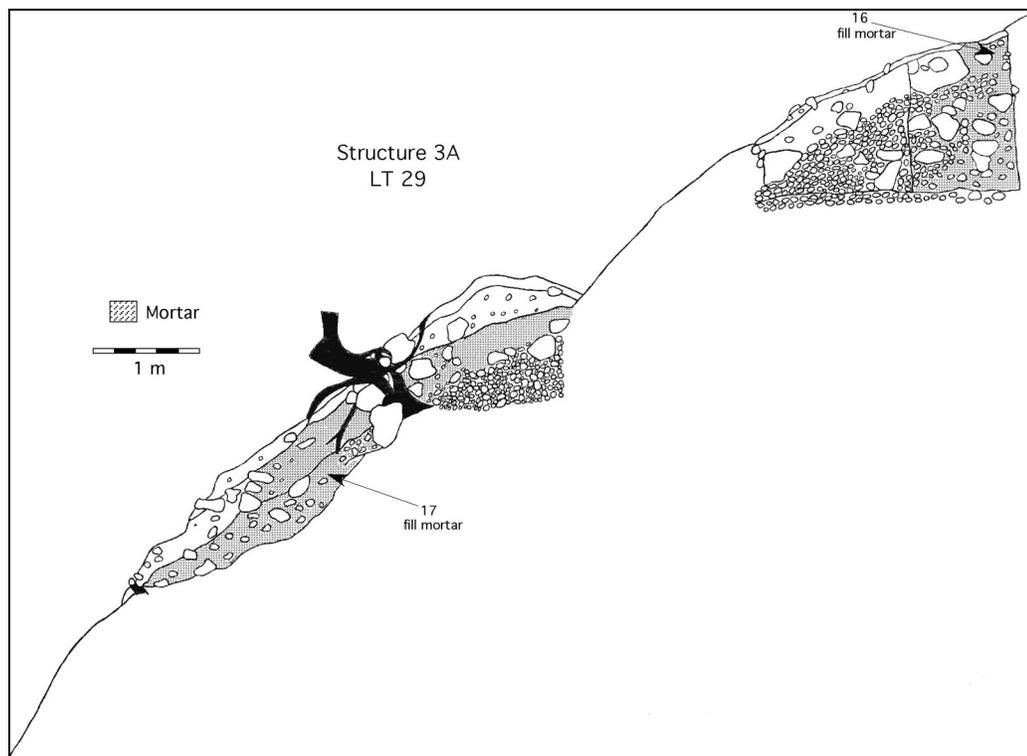
LT 29 is a long exposed trench, the top of which largely has been covered with plaster and dirt prior to the 2007 season for preservation purposes. It is located in the south side of the temple. Minor root activity was noted, as well as some insect disturbance. “The trench exposes strata of sorted cobbles and boulders, with and without mortar. The ones without mortar are made of cobbles and small boulders. The mortared portion is plaster with gravel” (Andrade 2005:45). Two samples were collected, which consisted of a loose gray (2.5Y 6/2) mixture of mortar, loam and pebbles (Figure 2.22). Even though much of the upper portion of LT 29 was covered, based on what was visible, there seems to be fewer yellow limestone boulders when compare to LT 25.

Figure 2.22 LT 29, Str. 3A. West wall.

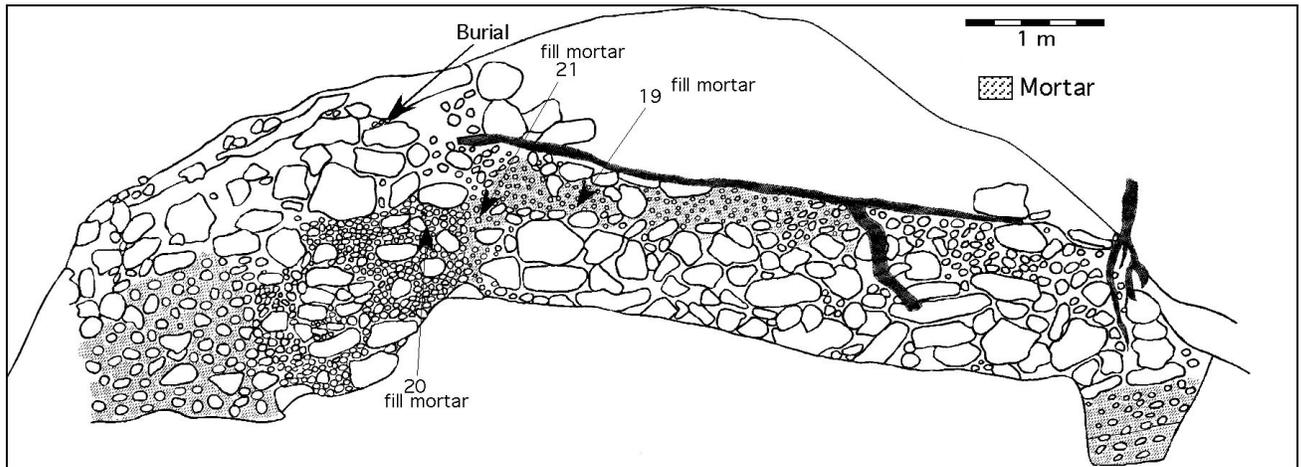
Temple 3B, the smallest temple at Yalbac, is located on the north side of Plaza 3. The temple has one looter's trench (LT 9) that cuts through the entire structure. The LT exposed mostly mortared fills, but does include phases built with large faced boulders without mortar (which had previously been defined as mortared in 2004; see Lucero 2005) (Figure 2.23). "The looter's missed part of a Late Classic burial immediately underneath the summit façade on the eastern side" (Lucero 2005:7). A noticeable amount of root activity was noted, as well as snake and insect disturbance. Hard limestone was noted in looter's debris. While collecting the three samples, pottery sherds and human bone fragments were noted on the trench floor, possibly from the burial found in 2004. Samples were gray (7.5YR 6/2) and loose with pebbles. Two plaster encrusted red-slipped sherds were noted, and one plaster encrusted Late Classic volcanic ash plate sherd was collected.

Figure 2.23 LT 9, Str. 3B. South wall.

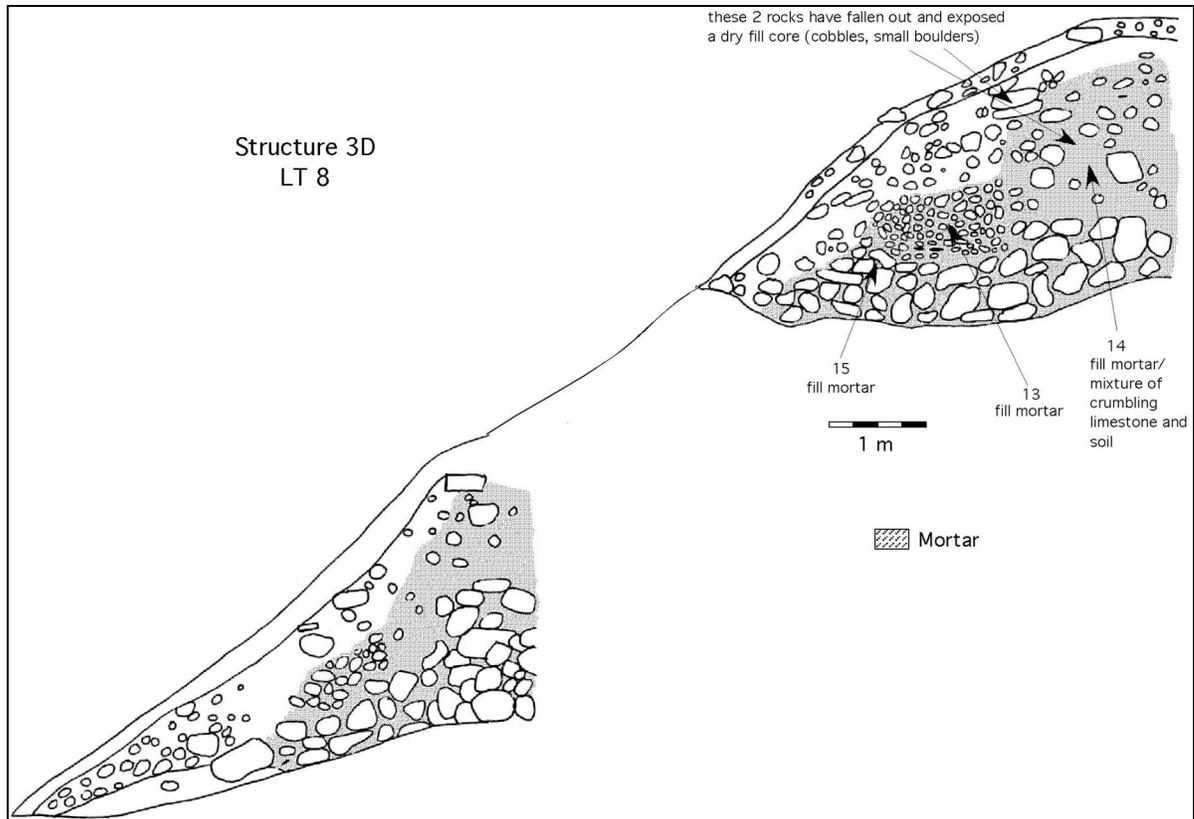
This trench exposed four terraces, which appear to have dry core and mortared fills with faced stones and cobbles and pebbles. In the lower part of the trench, limestone and river stone were noted. A great variation of stone types also was noted. "Looters disturbed a substantial tomb based on the artifacts strewn about, including a human skull fragments, a complete unmodified clam shell, a slate disc, obsidian, a marine shell disc and numerous sherds" (Lucero 2005:10). Three samples were collected (Figure 2.24), two of which were hard and compact (7.5YR 8/2), while the other was looser with small pebbles (5YR 6/1). Several volcanic ash body sherds and flakes were noted, noticeably more so than in any other LT; either they were used for fill or represent looter's debris. Out of the collapse debris we pulled out a pink-colored limestone (10R 6/6) that we do not think is dolomite.

Figure 2.24 LT 8, Str. 3D. North wall.

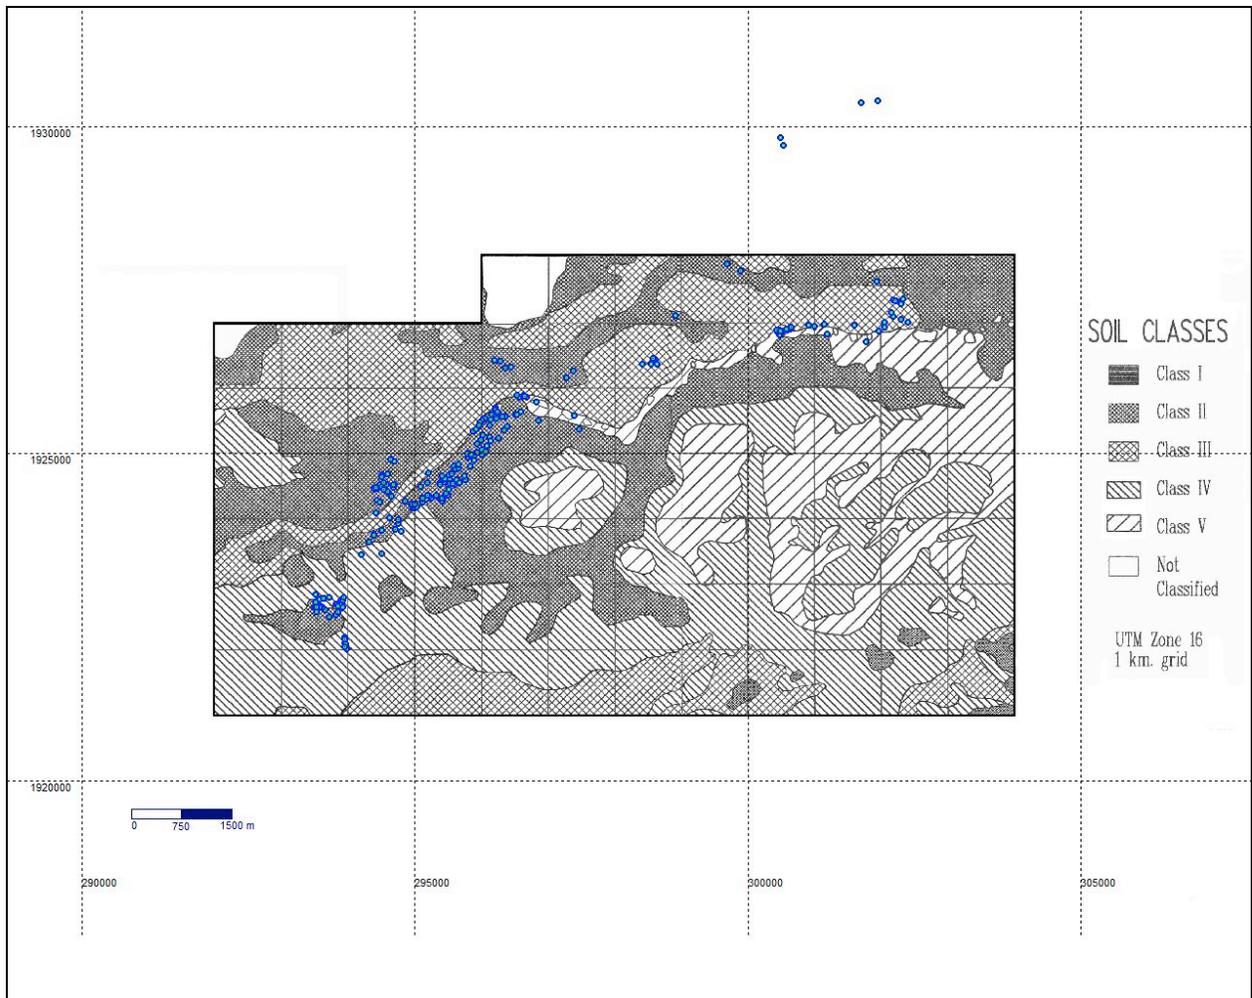
In the past, we have relied heavily on Fedick’s soil classifications in order to locate settlement (Fedick 1996). On the map below (Figure 3.2), I have replicated his five soil classifications as they relate to the survey area, and have overlain the settlement that was recorded. There is an obvious correlation between good (Class II) soils and the location of settlement, especially in the area between Yalbac and Pool 7. A large percentage of settlement location on the transect can be explained in this manner; the ancient Maya built their homes on good soils. Some of the only contradictions to this overall settlement strategy occur at the pools; I argue that this is because the importance of these pools as a location for ritual goes beyond farming considerations.

Figure 3.2: Soil classification in the VOPA settlement survey area with recorded settlement.
