Main Library • Illinois History and Lincoln Collections • Seventh Deck • Range D2
UIUC Library PresCons

Preservation Environment Evaluation

eClimateNotebook® - Image Permanence Institute - Rochester Institute of Technology - © 2016
Overview Report - Created: 2016-07-25

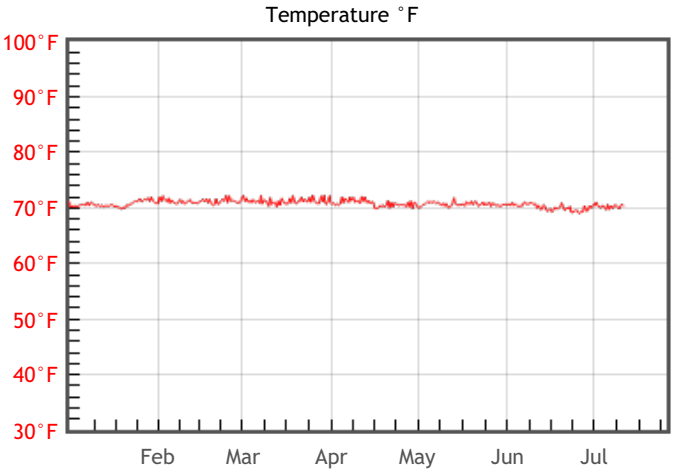
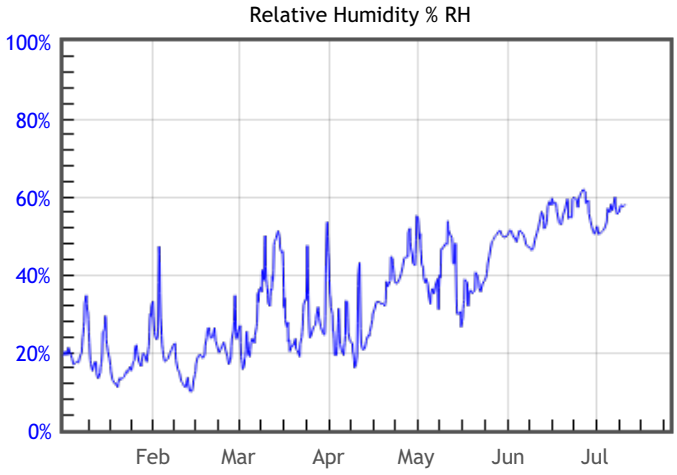
Lincoln 2 D2_P2_08131

Type of Decay	Risks & Metrics	Evaluation & General Comments
Natural Aging Chemical decay of organic materials	OK TWPI = 57	Generally OK, but fast decaying organic materials such as acidic paper, color photographs and cellulosic plastics will be at elevated risk due to the cumulative effects of temperature and humidity
Mechanical Damage Physical damage to hygroscopic materials	RISK % DC = 1.71 % EMC min = 4.1 % EMC max = 10.2	Heightened risk of physical damage to any hygroscopic material, such as paintings, rare books, furniture, paper, leather, film, or color photos, due to extremely low or high levels of humidity, and / or excessive humidity fluctuation.
Mold Risk Mold growth in area or on collection objects	GOOD MRF = 0	Minimal risk of mold growth.
Metal Corrosion Corrosion of metal components or objects	OK % EMC max = 10.2	Generally OK, but archeological or salt-encrusted metals may corrode due to extended periods of moderately high levels of humidity.

Temperature		Relative Humidity		Dew Point	
T°F Mean	70.7	**%RH Mean**	34	**DP°F Mean**	38.8
T°F Median	70.7	**%RH Median**	33	**DP°F Median**	39.8
T°F Stdev	0.8	**%RH Stdev**	15	**DP°F Stdev**	11.7
T°F Min	68.7	**%RH Min**	9	**DP°F Min**	9.1
T°F Max	74.1	**%RH Max**	63	**DP°F Max**	56.8

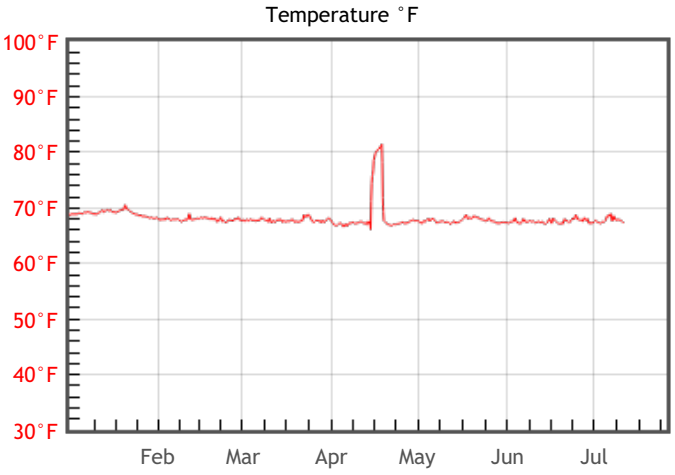
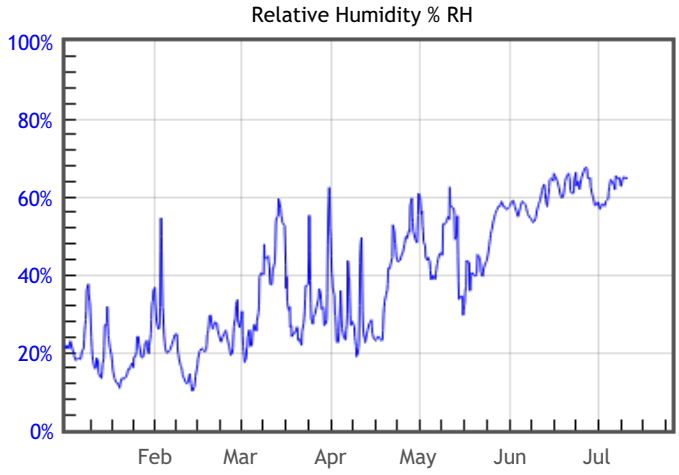
Lincoln 7 E16_P2_06268

Type of Decay	Risks & Metrics	Evaluation & General Comments
Natural Aging Chemical decay of organic materials	OK TWPI = 60	Generally OK, but fast decaying organic materials such as acidic paper, color photographs and cellulosic plastics will be at elevated risk due to the cumulative effects of temperature and humidity
Mechanical Damage Physical damage to hygroscopic materials	RISK % DC = 1.98 % EMC min = 4.5 % EMC max = 11.6	Heightened risk of physical damage to any hygroscopic material, such as paintings, rare books, furniture, paper, leather, film, or color photos, due to extremely low or high levels of humidity, and / or excessive humidity fluctuation.
Mold Risk Mold growth in area or on collection objects	GOOD MRF = 0	Minimal risk of mold growth.
Metal Corrosion Corrosion of metal components or objects	RISK % EMC max = 11.6	Heightened risk of metal corrosion due to extended periods of high levels of humidity.

Temperature		Relative Humidity		Dew Point	
T°F Mean	68.1	**%RH Mean**	38	**DP°F Mean**	39.3
T°F Median	67.8	**%RH Median**	36	**DP°F Median**	40.3
T°F Stdev	1.8	**%RH Stdev**	17	**DP°F Stdev**	12
T°F Min	64.2	**%RH Min**	10	**DP°F Min**	9
T°F Max	82.2	**%RH Max**	69	**DP°F Max**	57.4

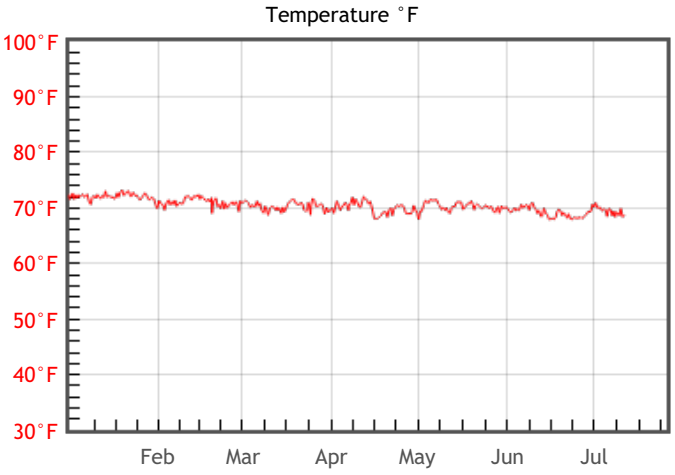
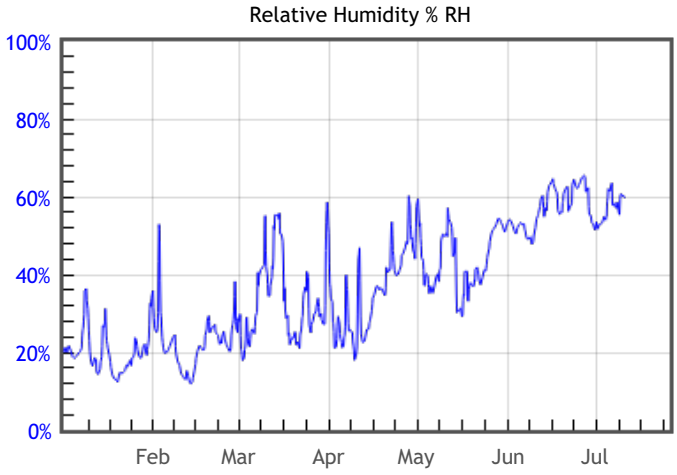
Lincoln 8 E4_P2_03108_b

Type of Decay	Risks & Metrics	Evaluation & General Comments
Natural Aging Chemical decay of organic materials	OK TWPI = 55	Generally OK, but fast decaying organic materials such as acidic paper, color photographs and cellulosic plastics will be at elevated risk due to the cumulative effects of temperature and humidity
Mechanical Damage Physical damage to hygroscopic materials	RISK % DC = 1.76 % EMC min = 4.5 % EMC max = 10.8	Heightened risk of physical damage to any hygroscopic material, such as paintings, rare books, furniture, paper, leather, film, or color photos, due to extremely low or high levels of humidity, and / or excessive humidity fluctuation.
Mold Risk Mold growth in area or on collection objects	GOOD MRF = 0	Minimal risk of mold growth.
Metal Corrosion Corrosion of metal components or objects	RISK % EMC max = 10.8	Heightened risk of metal corrosion due to extended periods of high levels of humidity.

Temperature		Relative Humidity		Dew Point	
T°F Mean	70.4	**%RH Mean**	37	**DP°F Mean**	40.4
T°F Median	70.1	**%RH Median**	35	**DP°F Median**	41
T°F Stdev	1.8	**%RH Stdev**	15	**DP°F Stdev**	10.8
T°F Min	66.3	**%RH Min**	11	**DP°F Min**	15
T°F Max	78.6	**%RH Max**	67	**DP°F Max**	57.5

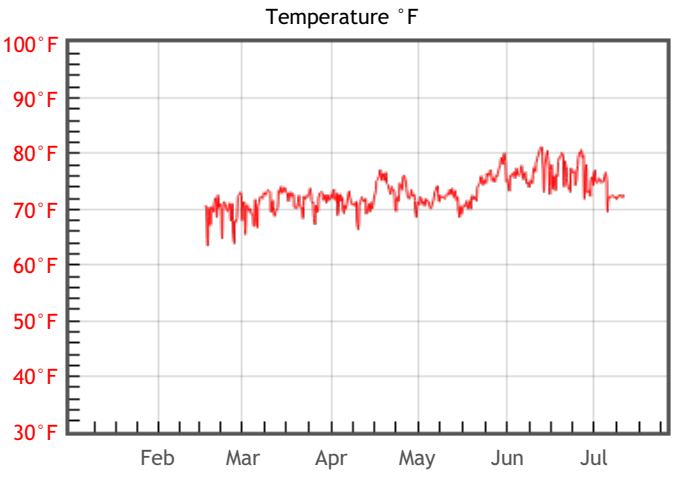
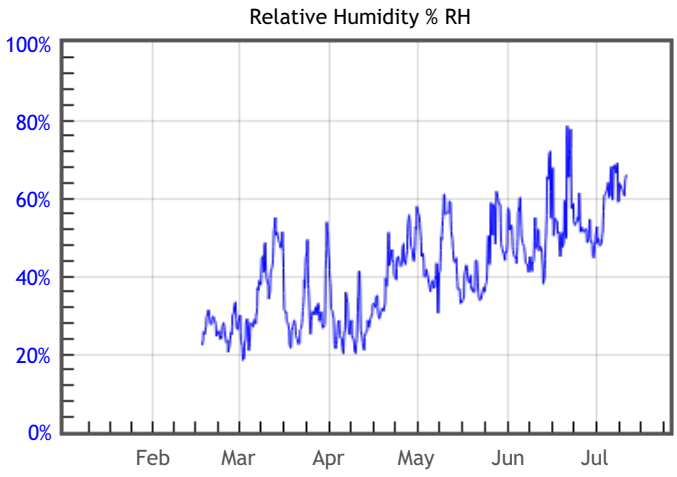
P2_02622

Type of Decay	Risks & Metrics	Evaluation & General Comments
Natural Aging Chemical decay of organic materials	RISK TWPI = 40	Accelerated rate of chemical decay in all organic materials due to the cumulative effects of temperature and humidity, with especially high risk for fast decaying organic materials such as acidic paper, color photographs and cellulosic plastics.
Mechanical Damage Physical damage to hygroscopic materials	OK % DC = 1.19 % EMC min = 6 % EMC max = 10.2	Generally OK, but sensitive or fast responding hygroscopic materials such as paintings, rare books, vellum manuscripts or musical instruments will be at elevated risk of physical damage due to fluctuations of humidity.
Mold Risk Mold growth in area or on collection objects	GOOD MRF = 0.06	Minimal risk of mold growth.
Metal Corrosion Corrosion of metal components or objects	OK % EMC max = 10.2	Generally OK, but archeological or salt-encrusted metals may corrode due to extended periods of moderately high levels of humidity.

Temperature		Relative Humidity		Dew Point	
T°F Mean	73	**%RH Mean**	41	**DP°F Mean**	47.1
T°F Median	72.6	**%RH Median**	42	**DP°F Median**	48.3
T°F Stdev	3.1	**%RH Stdev**	13	**DP°F Stdev**	10.2
T°F Min	63.1	**%RH Min**	16	**DP°F Min**	22.6
T°F Max	81.8	**%RH Max**	83	**DP°F Max**	71.7

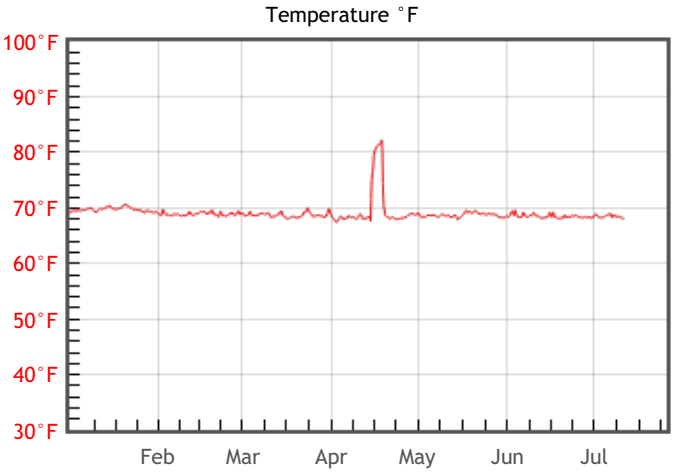
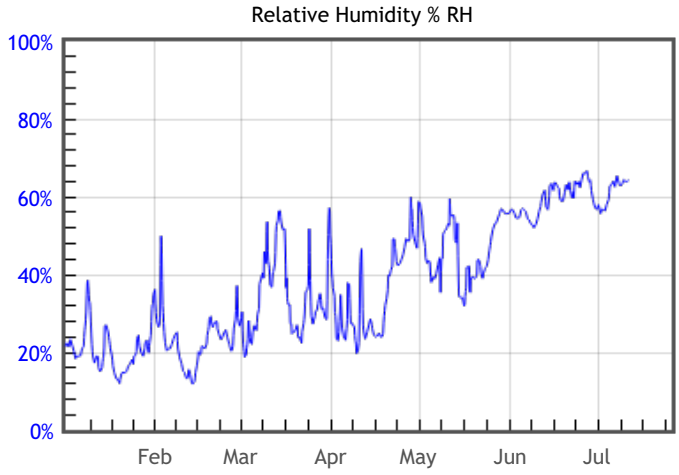
Temp IHLC_P2_03110

Type of Decay	Risks & Metrics	Evaluation & General Comments
Natural Aging Chemical decay of organic materials	OK TWPI = 59	Generally OK, but fast decaying organic materials such as acidic paper, color photographs and cellulosic plastics will be at elevated risk due to the cumulative effects of temperature and humidity
Mechanical Damage Physical damage to hygroscopic materials	RISK % DC = 1.92 % EMC min = 4.5 % EMC max = 11.4	Heightened risk of physical damage to any hygroscopic material, such as paintings, rare books, furniture, paper, leather, film, or color photos, due to extremely low or high levels of humidity, and / or excessive humidity fluctuation.
Mold Risk Mold growth in area or on collection objects	GOOD MRF = 0	Minimal risk of mold growth.
Metal Corrosion Corrosion of metal components or objects	RISK % EMC max = 11.4	Heightened risk of metal corrosion due to extended periods of high levels of humidity.

Temperature		Relative Humidity		Dew Point	
T°F Mean	69	**%RH Mean**	38	**DP°F Mean**	40
T°F Median	68.7	**%RH Median**	36	**DP°F Median**	41.2
T°F Stdev	1.7	**%RH Stdev**	16	**DP°F Stdev**	11.4
T°F Min	66.9	**%RH Min**	12	**DP°F Min**	13.8
T°F Max	83.1	**%RH Max**	68	**DP°F Max**	57.5
